Model    X-77  
          X-77GT

**SUBJECT:    HUM OR BUZZ FROM MUSIC LIGHT**

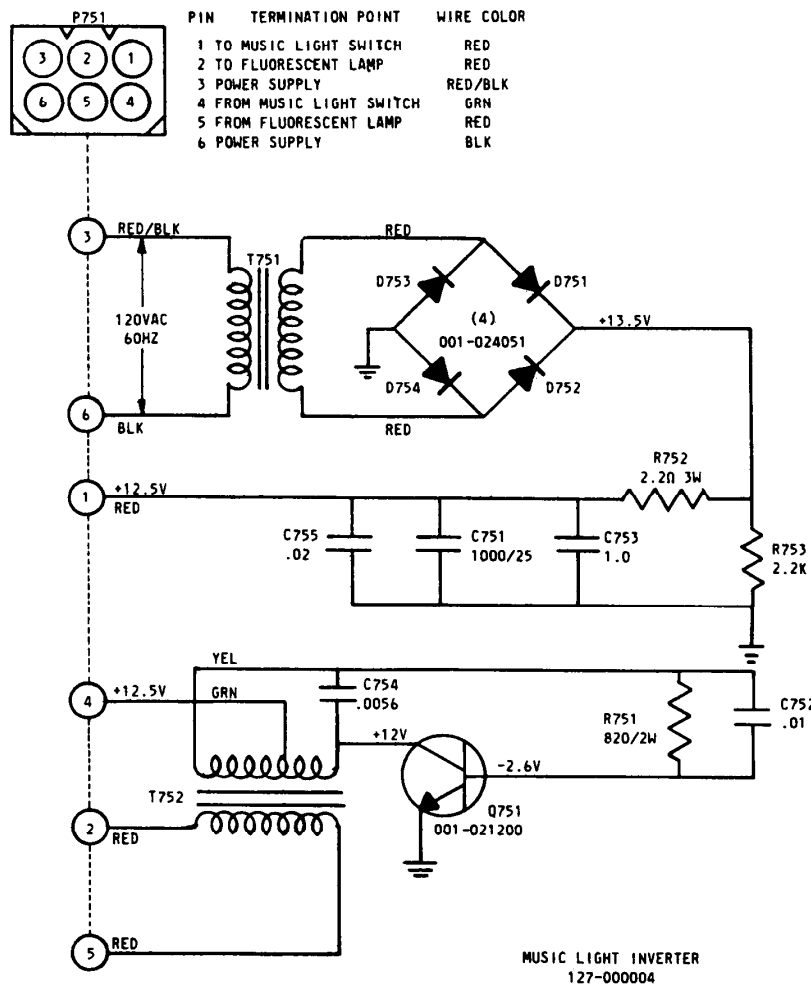
Enclosed you will find a revised schematic for the Music Light Inverter. In cases where persistent noises have been difficult to remove, rewiring and adding components per the schematic should alleviate the condition.

Also, it may be necessary to remove a ground connection from the left hand fluorescent light socket. This ground lug is connected to a mounting screw. This has been in many cases the source of additional hum because it makes up a ground loop.

The specific changes to take note of are the change in value of R752 from 1 ohm to 2.2 ohms, the relocation of C751, the addition of C755 (RF Bypass). C754 (.0056) is not part of this specific change, however, it was an addition since the service manual was first printed.

The new wiring should agree with the schematic shown below.
