Model X-77
 X-77GT

SUBJECT: HUM OR BUZZ FROM MUSIC LIGHT

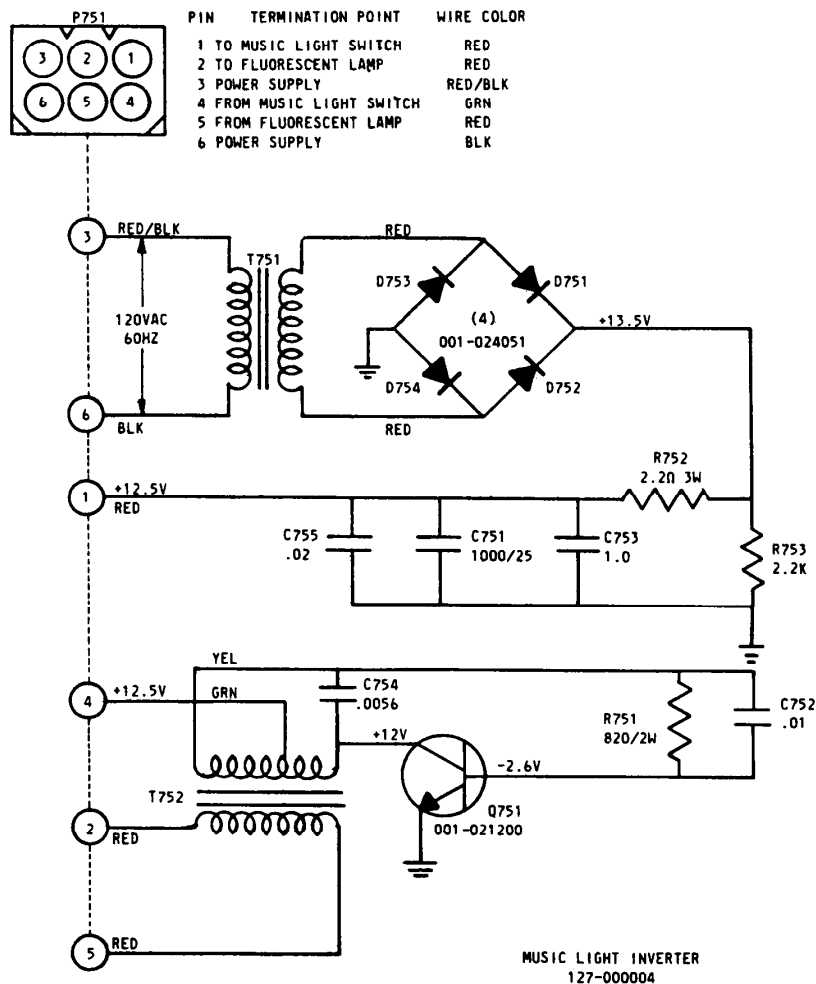
Also, it may be necessary to remove a ground connection from the left hand fluorescent light socket. This ground lug is connected to a mounting screw. This has been in many cases the source of additional hum because it makes up a ground loop.

Enclosed you will find a revised schematic for the Music Light Inverter. In cases where persistent noises have been difficult to remove, rewiring and adding components per the schematic should alleviate the condition.

The specific changes to take note of are the change in value of R752 from 1 ohm to 2.2 ohms, the relocation of C751, the addition of C755 (RF Bypass). C754 (.0056) is not part of this specific change, however, it was an addition since the service manual was first printed.

The new wiring should agree with the schematic shown below.
