Model H-100
 Below Serial
 No. 15,000

SUBJECT: SPORADIC CRACKLING NOISE

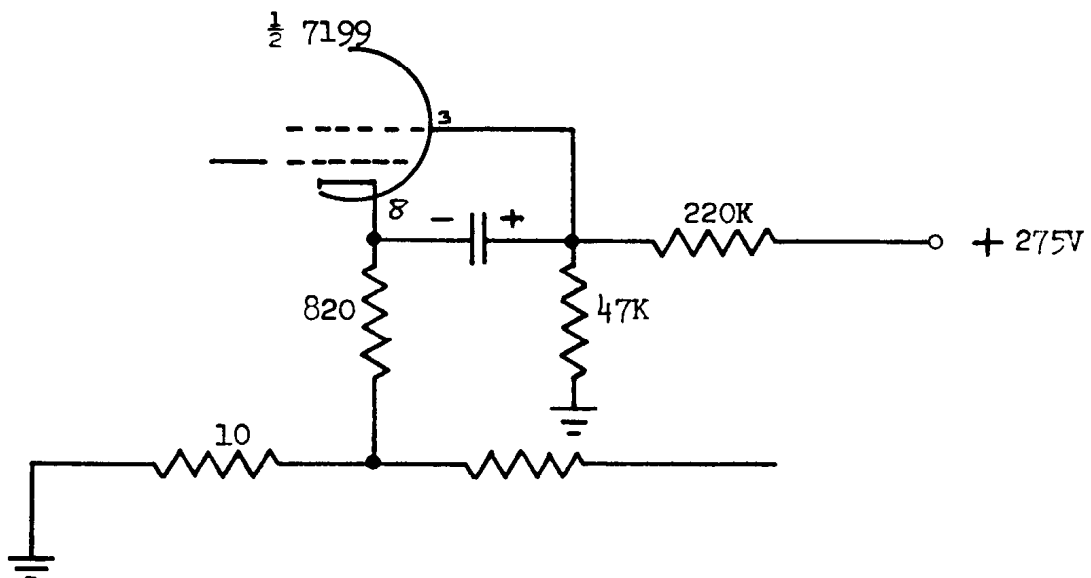
The capacitors may be replaced by non-polarized local purchase items or from Hammond Organ Company (Part #407-080229), or by standard polarized types which are more readily available. Observe polarity when polarized replacements are installed. See sketch below.

These capacitors are C-332, C-350 and C-366. They are non-polarized types, rated at 20 MFD/50V.

If "warm-up" noise is the problem, remove the 7199 from the noisy channel and allow it to cool completely before reinserting into the socket, or use a fresh, known good, tube. Run through the applicable test above at least twice to be sure of your diagnosis, then replace all three capacitors to avoid repeat calls.
